Conditions of life rafts

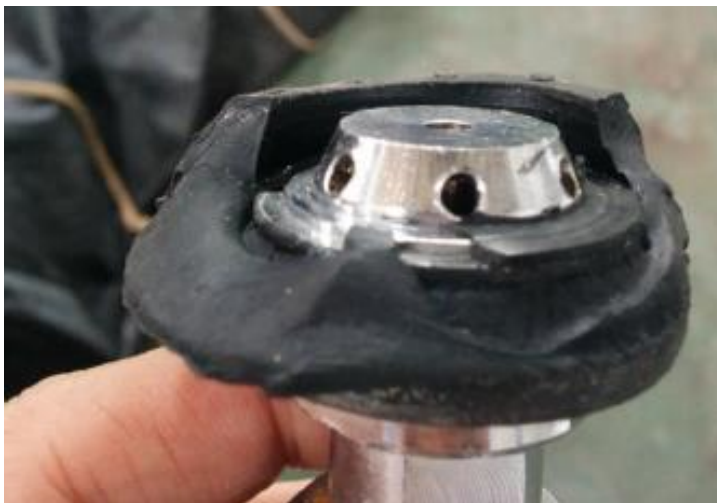
Inspection of the second life raft, in deflated condition, showed the raft separated and detached into three different sections, i.e. the top buoyancy unit, bottom buoyancy unit and floor unit.

Additionally, there was evidence of broken one-way safety valve tube from its assembly unit i.e. both tubes were ripped off at the base (hardened rubberised compound) connected to the buoyancy unit – thus, the immediate loss of air.

According to passengers' account, after the bottom buoyancy unit was deflated, the floor of the raft began to tear at the side. Under normal operating condition, the raft of the floor was held in place by both buoyancy units. Therefore, when the bottom unit failed, higher stress was placed on the already stressed floor from passengers' weight that eventually caused the floor to tear at the side.
